Phase 2 Evaluation and Engineering Assessment and Golf Course Renovation Harry L. Jones Sr. Golf Course

Ratcliffe Golf Services, Inc.
800 Radio Road
Charlotte, North Carolina 28216

02217302.00 | October 2, 2018

SCS ENGINEERS P.C.

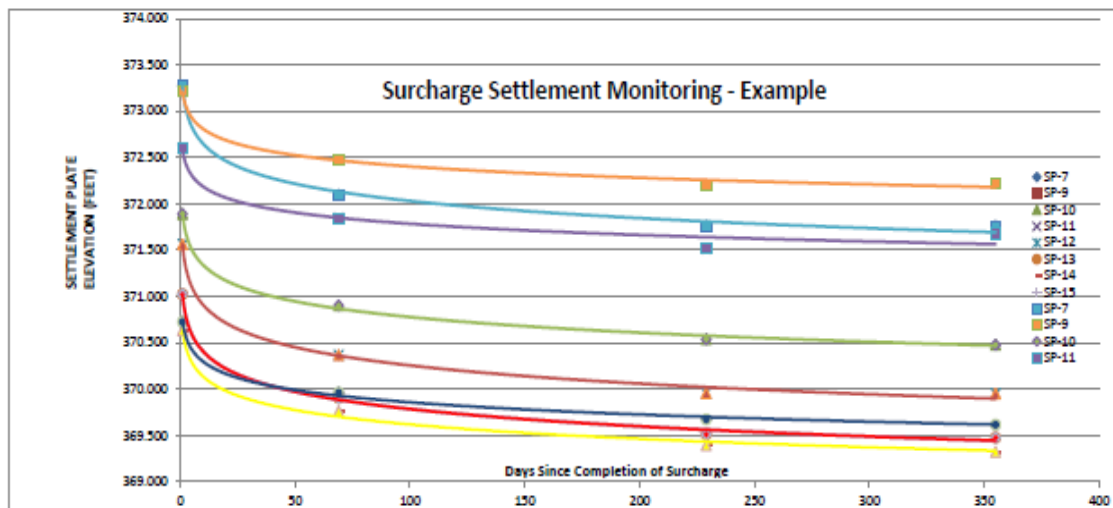
Figure 2. Surcharge Settlement Monitoring Example

During the surcharge period, the engineer will be evaluating the data and creating graphs depicting settlement versus time as shown on Figure 2.
